# **Detecting and Eliminating Illicit Discharges in Montpelier: Final Report**

PROJECT NO.

16-002

Cover photo: Catchbasin at Main Street Middle School after dye testing neighboring apartment building

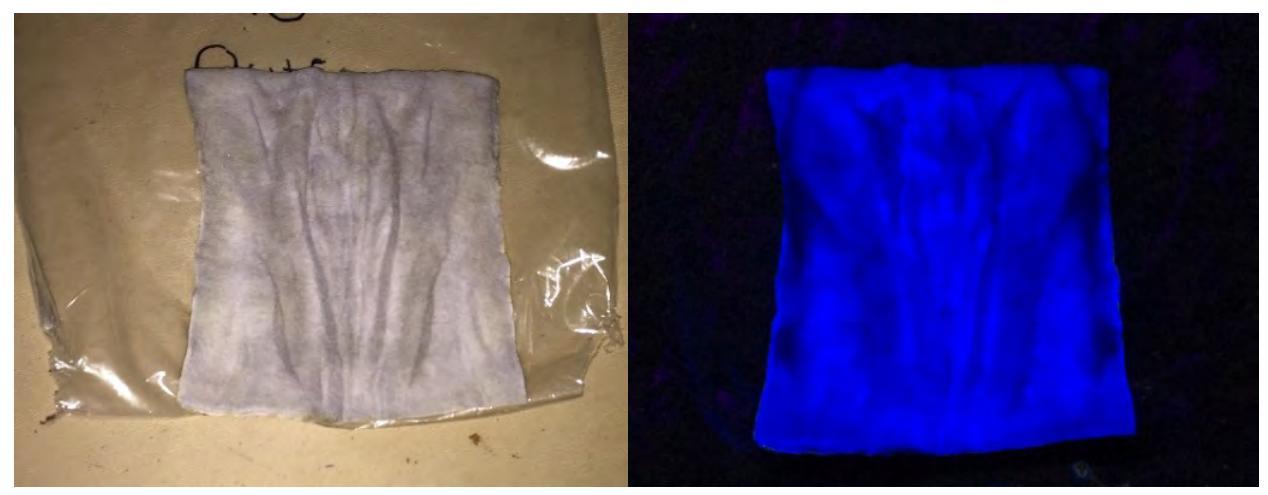
Figure 1. Positive optical brightener monitoring pad under fluorescent (left) and UV (right) lamps.

Optical brightener monitoring was performed at outfalls and selected catchbasins and manholes that were flowing at the time of inspection, in accordance with Stone Environmental SOP 6.38.0 (**Appendix B**). To test for optical brightener, a cotton pad was placed in the flow stream for a period of 4–10 days, after which the pad was rinsed, dried, and viewed under a long-wave ultraviolet light ("black light"). Florescence of the pad (seen on the pad in Figure 1) indicates the presence of optical brightener. Pads were held in a sleeve of fiberglass window screen, clipped to the rim of the outfall pipe or secured with fishing line to a rock or other anchor. At catchbasins and manholes located at junctions in the storm sewer, pads were deployed in incoming pipes if possible, but were often hung from the catchbasin grate or manhole rung into the sump. An advantage of optical brightener monitoring is that some intermittent or dilute wastewater discharges can be detected due to the multiple-day exposure of the pad, whereas the contaminant may not be detected in tests performed on grab samples.

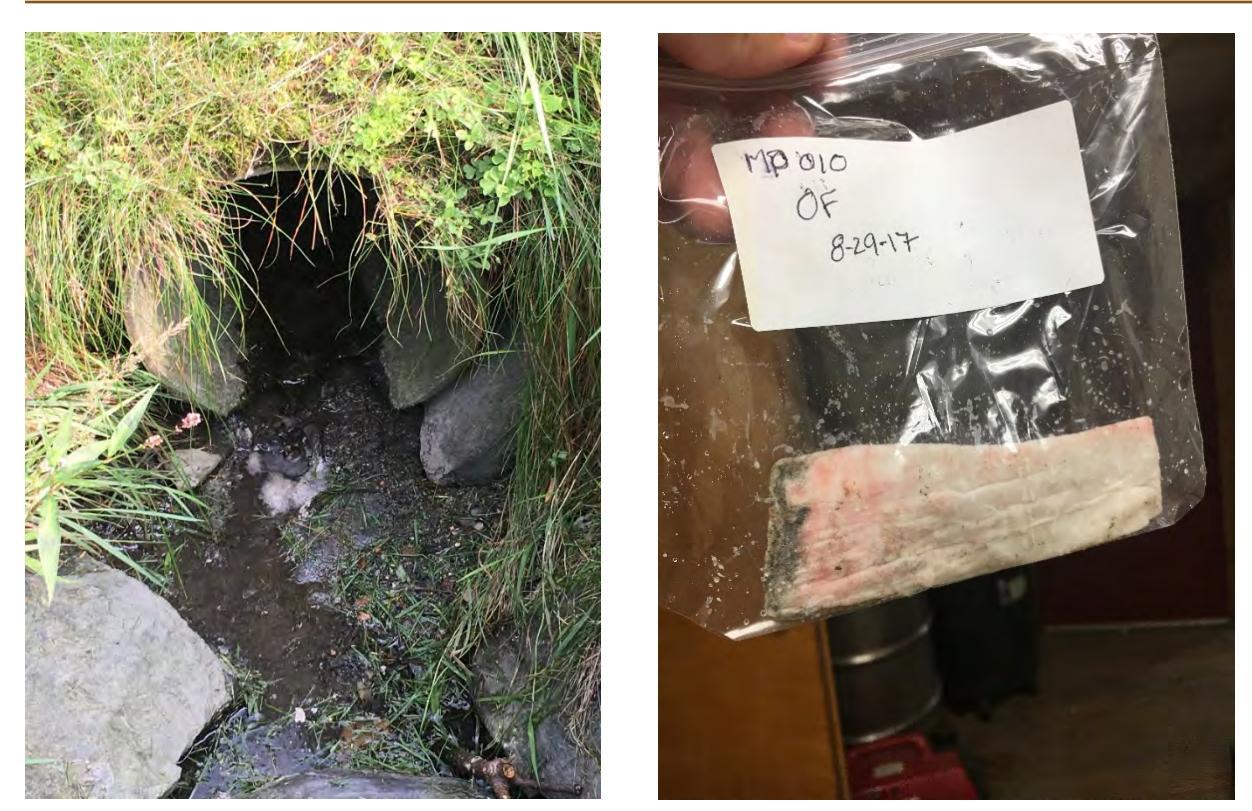
Figure 2. Suds at the MP010 outfall, August 17, 2017

| Date<br>Assessed | Flow<br>Condition | Ammonia<br>(mg/L) | Free<br>Chlorine<br>(mg/L) | MBAS<br>(mg/L) | Specific<br>Cond.<br>(µs/cm) | OB Result | Observations |
|---|---|---|---|---|---|---|---|
| 8/29/17 | Trickling | n/a | n/a | n/a | n/a | Positive (strong) | Clear, no odor. Suds present. Red dye from sanitary sewer found on pad. |

- Optical brightener was detected, and suds were observed, at the outfall during the initial assessment in May 2016.
- Monitoring pads were deployed throughout the system on three dates in June, August, and October 2016. Optical brightener was detected only at the outfall.
- Suds were observed at the outfall on multiple dates in 2016 and 2017, including August 17, 2017 (Figure 2).
- On August 25, 2017, red sewer dye was added in the sanitary manhole (SM1) at the intersection of Westwood Drive and Towne Hill Road. This manhole is adjacent to CB1. There was no flow in CB1, yet the outfall was trickling. A monitoring pad was deployed at the outfall.
- The pad was retrieved from the outfall on August 29, 2017. Red dye (Figure 3) and optical brightener were observed.

Figure 3. Red dye on pad, August 29, 2017

• On January 7, 2020 Montpelier DPW staff led by Eric Ladd smoke tested the MP010 system. They plugged off the storm lines upstream of CB1, restricted the outlet, and injected smoke in CB1. Smoke was observed issuing from the roof vent at 498 Towne Hill Road. Given how quickly smoke reached the roof vent, Eric Ladd suspects there is a cross connection rather than a leak or break. Smoke was also observed at a sanitary manhole, though it is possible that this was due to wind blowing the smoke around. However, smoke was eventually observed coming from the vent at 513 Town Hill Road, across the street. The stormdrain was evacuated and then the sanitary system was tested. The house at 498 Town Hill Road smoked immediately from the same vent as before. Eventually there appeared to be a small amount of smoke in CB1 and a definite sewer odor. Eric Ladd's working theory is that there is a gray water line (washing machine) at 498 Towne Hill Road connected to a basement drain line that shares a common roof vent with their sewer lateral. His next step is to gain access to the house and dye test the washer and toilets.

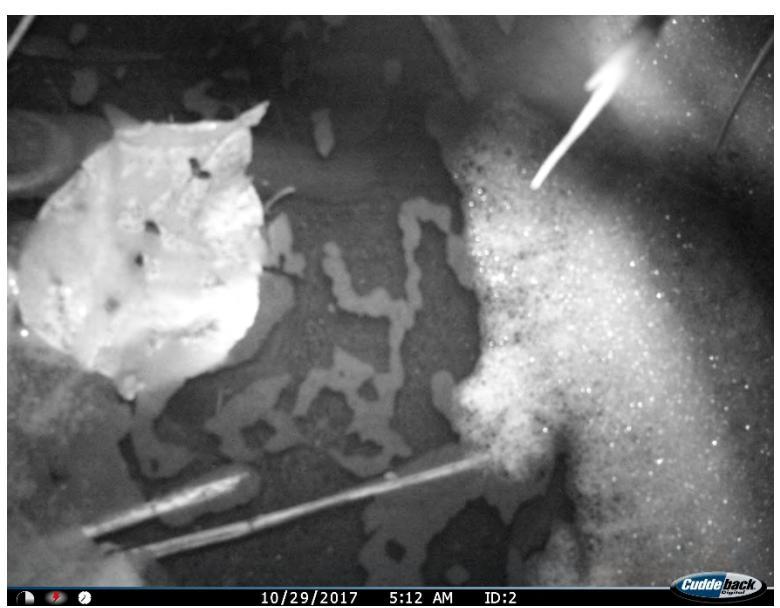
Figure 4. Outfall MP250 with suds (time-lapse camera image)

- On May 26, 2016 suds were observed at the MP250 outfall. Ammonia, MBAS, and free chlorine concentrations were below detection and optical brightener was not present.
- OB monitoring was performed on three subsequent dates in 2016 and 2017; no OB was detected. However, suds (Figure 4) were observed on each visit.
- Mapped catchbasins CB1 and CB2 (Appendix D, Map 4) could not be located, which limited our ability to bracket contaminants in the system.

Conclusion: Based on repeated observations of suds at the outfall, under high and low flow conditions, and the lack of optical brightener or elevated ammonia concentrations, we suspect there is a washwater connection to this system. We suspect, but have not confirmed, that the source of the washwater is in the baseball stadium. A roof drain from the area of the baseball stands is mapped as connected with the MP250 stormdrain. It is possible there is a sink or drain used for washing connected to this roof drain. This possibility should be investigated further with the assistance of Montpelier DPW.

**Resolution:** Pending identification of a washwater source. Dye testing of any facilities at the baseball stadium is recommended.

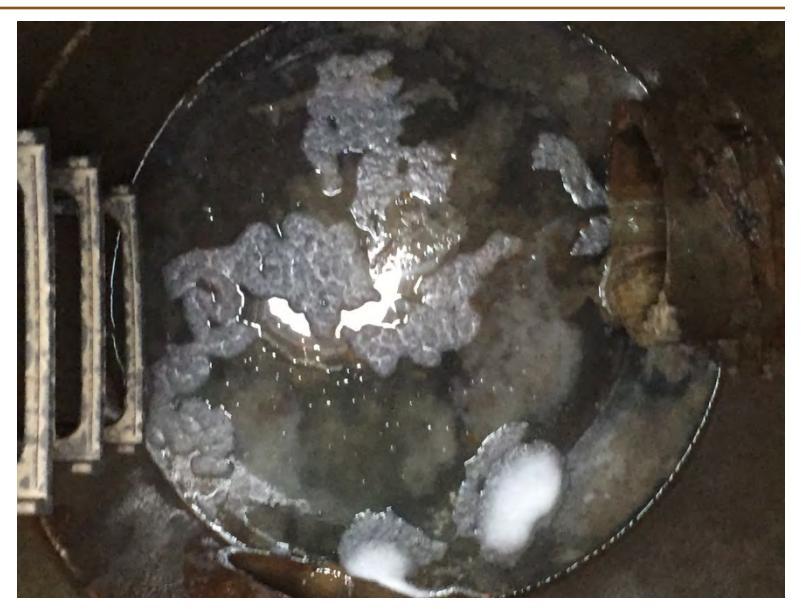
Figure 5. Catchbasin CB6 on the Main Street Middle School property

• Ammonia and wastewater odor were detected at the outfall on May 27, 2016. The flow was followed back to a catchbasin on the Main Street Middle School property. In CB6, we observed suds, toilet paper, and feces (Figure 5). The flow and suds were coming from a pipe aligned toward North Street (in the opposite direction from the school).

- On June 1, 2016 Montpelier DPW deployed a tracked camera at CB6. Four pipes were identified draining to the main line entering CB6. There are two pipes entering at roughly 43 ft upstream from the catchbasin and a third around 68 ft that all appeared greasy around the outlet. While we were watching the catchbasin the flow picked up and some suds came through.
- On June 7, 2016 Stone and Montpelier DPW staff dye tested toilets in 24, 32, and 46

North Street and in 172 and 176 Main Street. The sanitary sewer from the apartment building at 172 Main Street/1 Scribner Place was directly connected to the stormdrain above the manhole (labelled CB7) under the basketball hoop. At 24 and 32 North Street we inspected basement plumbing connections, which looked OK. We could not access the basement at 176 Main Street. The front unit at 176 Main is connected properly; however, the dye test in the back apartment was inconclusive. Orange dye was added at the same time red dye was used at 172 Main. This test either needs to be repeated or the basement needs to be accessed to rule out a connection to the stormdrain. While dye testing houses on North Street, DPW staff observed flow and detergent suds pass through catchbasin CB6 but not the manhole under the basketball hoop. This observation suggests a yet undiscovered connection to one of the two pipes discharging to the storm sewer between CB6 and the manhole under the basketball hoop.

**Resolution:** We recommend additional investigation in this system, now that the major problem at 172 Main St./1 Scribner Place has been resolved. We recommend smoke testing this system at a time when school is not in session. If necessary, we also recommend a dye test in the rear apartment unit at 176 Main Street.

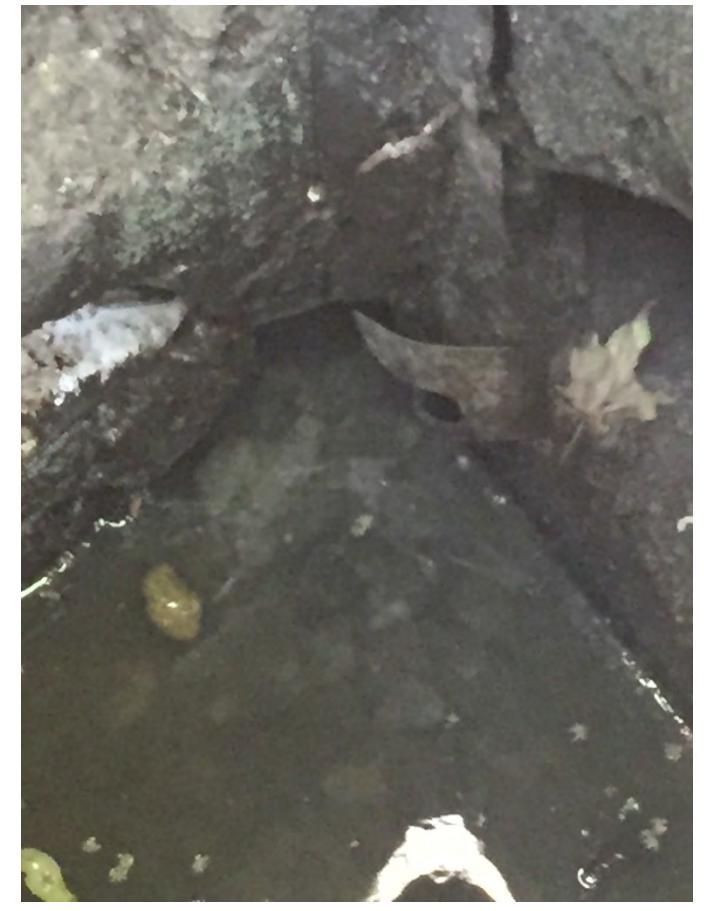
Figure 6. Hole (connected pipe not visible) in corner of CB3

• In June 2016, feces and toilet paper were observed entering catchbasin CB3 near 153 State Street. via a small diameter pipe in the corner of the basin (Figure 6). The outfall tested positive for presence of optical brightener. Ammonia concentrations were elevated both at the outfall and in CB3. Stone notified the City of Montpelier of this findings on June 17, 2016. We suspected a direct connection from the building at 153 State Street. Montpellier DPW dye tested a bathroom at 153 State Street and

inspected the basement plumbing. Dye was observed in the sanitary sewer and not in the storm sewer. Since there appeared to be only one sewer pipe exiting the building's basement, Montpelier DPW concluded there was no illicit connection from this building. Montpelier DPW also dye tested facilities and inspected basement plumbing in adjacent buildings on State Street, again finding no problems. Stone dye tested the sanitary sewer on lower State Street west of catchbasin CB3 and did not observe dye in the separate storm sewer.

On October 19, 2016, Stone, Montpelier DPW (Kurt Motyka, Eric Ladd, and Mike Pappineau), and Wayne Graham of Vermont Rural Water Association performed camera inspection and smoke testing of the sanitary sewer and storm sewer on lower State Street. Smoke testing did not reveal any inappropriate cross connections from buildings on State Street to the storm sewer. However, immediately east of catchbasin CB3 smoke did cross over between the sanitary sewer and a corrugated steel underdrain that discharges to catchbasin CB3. While there did not appear to be a direct connection between the sanitary and the storm sewers, the approximate location where the smoke entered each pipeline was visible on camera within each pipeline. When smoking catchbasin CB3, it appeared that the smoke flowed through the underdrain

and entered the sanitary sewer at a pipe joint. Stone observed an accumulation of sediment and pools of water near the point at which the underdrain crosses under the sanitary sewer. Stone made the preliminary recommendation to repair or replace the section of the sanitary sewer pipe crossing over the underdrain to eliminate this indirect connection.

**Conclusion:** The City of Montpelier eliminated a direct wastewater connection to system MP580 from 153 State Street. However, subsequent optical brightener testing has confirmed the existence of a second, indirect wastewater discharge to this system. As indicated by smoke testing conducted in October 2016, it appears that sanitary wastewater is leaking from the sewer main into the underdrain and discharging into catchbasin CB3.

**Resolution:** The second wastewater discharge to this system requires correction. We recommend sliplining a section of the sewer main on State Street where it crosses over the underdrain east of catchbasin CB3.

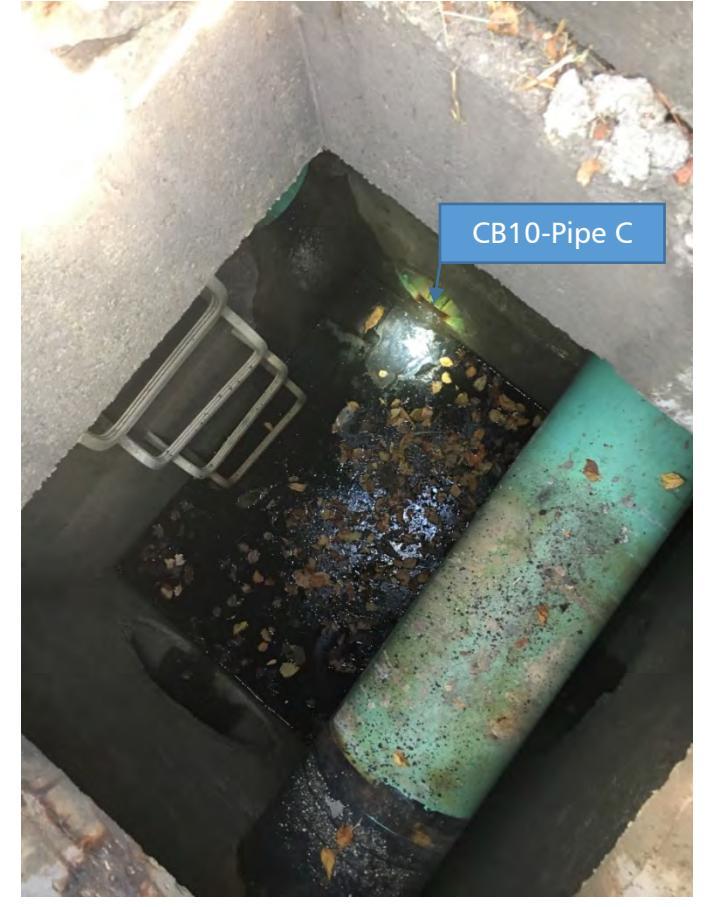
Figure 7. Unmapped Pipe C in catchbasin CB10, September 21, 2017

- On September 21, 2017, elevated ammonia levels were detected in CB10 and downstream catchbasin CB3. Furthermore, a wastewater odor was observed in both basins and a small amount of suds appeared to enter CB10 from an unidentified pipe (Pipe C; Figure 7).

**Resolution:** The origin and connection to Pipe C in catchbasin CB10 require further investigation. We recommend the Montpelier DPW inspect this pipe with a sewer camera.

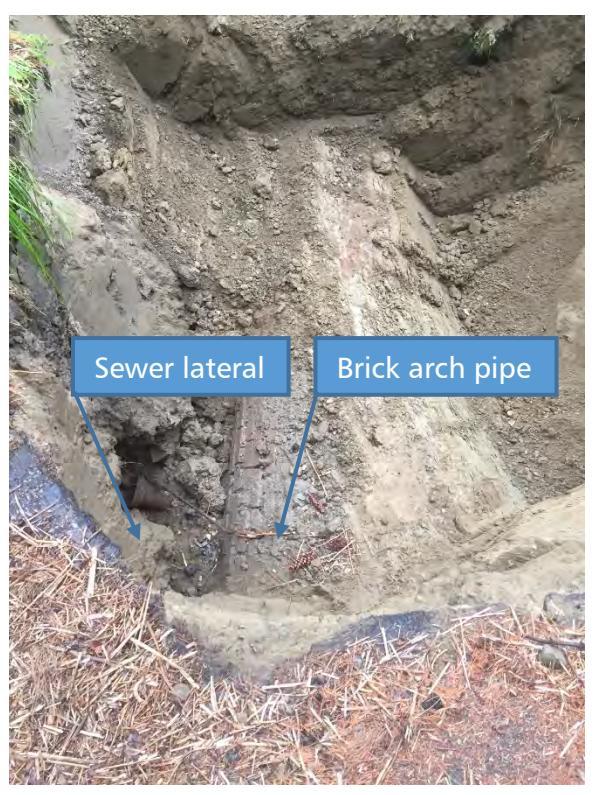
Figure 8. Top of brick arch stormdrain, July 17, 2017

**Conclusion:** The City of Montpelier eliminated a direct wastewater connection to this system.

**Resolution:** This City Engineer stated that the City plans to abandon entirely the section of the brick arch pipe between CB1 and CB2 after rerouting CB2.
