Riparian Buffer Planting Survey123 Checklist User Guide

Summary: This checklist should be used by qualified and trained verifiers to assess implemented riparian buffer planting projects. See the [Verification Program Standard Operating Procedure \(SOP\)](#) for details on the verification process and to access the applications. Verification visits occur throughout the field season, however visiting riparian buffer planting projects in late spring is the best timing for accessing and locating planted vegetation. Prior to a visit, review project details including planting map, planting plan with planting density, species list, reports, and notes from prior verification visits. If possible, bring these documents to reference in the field. This user guide provides an overview of all the questions in the riparian buffer checklist and best practices on collecting data and images.

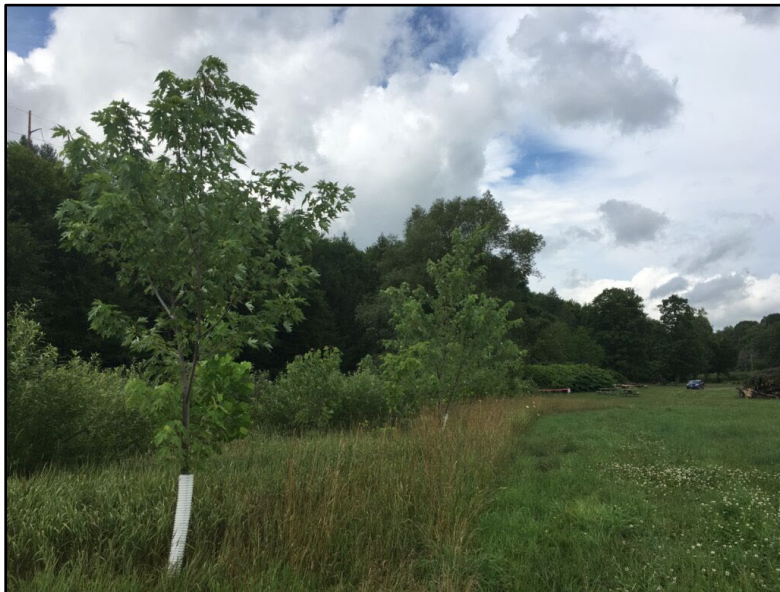
Photo of buffer planting showing full extent of planting area

Verifier note: photo quality is best when taken with tablet/phone’s camera app and then uploaded to Survey123. Try to take a photo that shows the full extent of the practice (take multiple photos as needed). Best practice is to take the photo(s) from same location or using a landmark, such as a large tree or structure that is visible as the forest grows. Enter this information in the photo description question below. If helpful, mark photo point location using latitude/longitude (some phones/tablets automatically log location in image metadata).

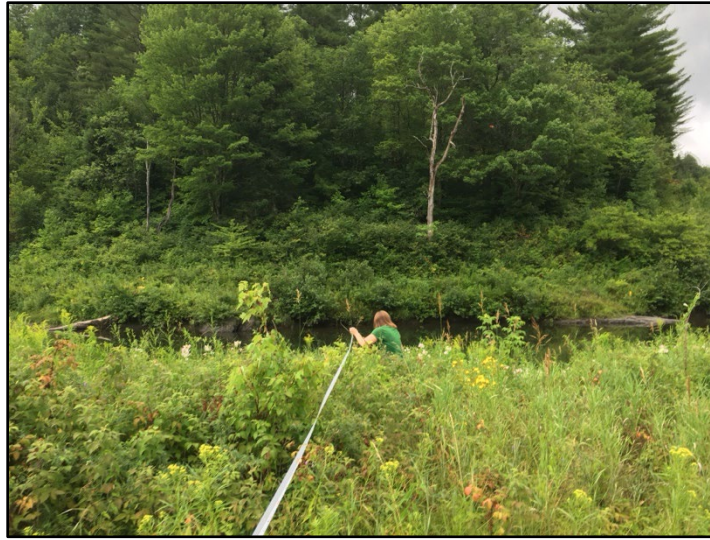
Verifier using field tape measure to measure buffer width.

Verifier note: select three locations distributed throughout the planting area to measure buffer width (ft) using a field tape measure. Best practice is to select the monitoring locations during the first verification visit and use those same during all subsequent visits for consistency and to monitor change over time. Measurements should be taken perpendicular to the streambank edge. Use planting map to determine initial planting zone and mark monitoring locations.

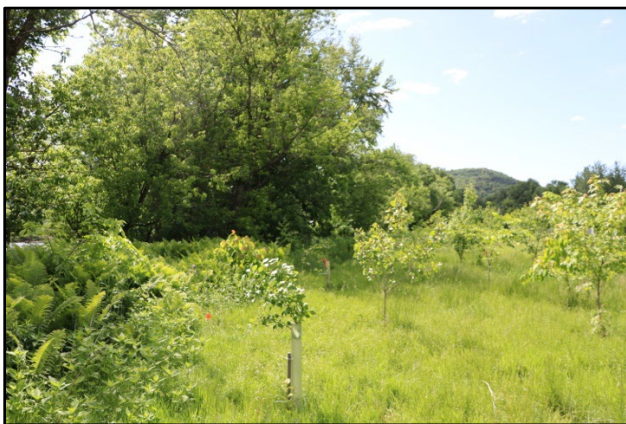
90% or more of the plantings appear healthy.

Verifier note: the intent of this question is to look closely at planted vegetation, rather than other volunteer species that have established within the planting area. Healthy plants show signs of new growth and have leafed out. Plants that are unhealthy have discolored or small leaves, dead branches, and evidence of deer browse, voles, or disease.

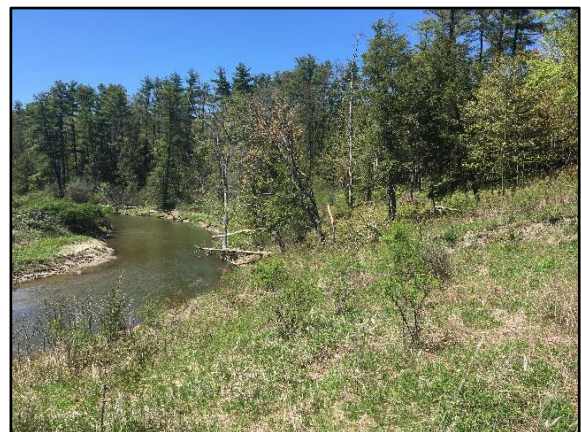
More than 50% of plantings do not appear healthy.
