Memorandum

Re: Jay Peak Resort
2017 Water Quality Remediation Plan Update

JAY PEAK RESORT PROPOSED SOUTH MOUNTAIN BRANCH BMP'S, 2017
MAY 12, 2017

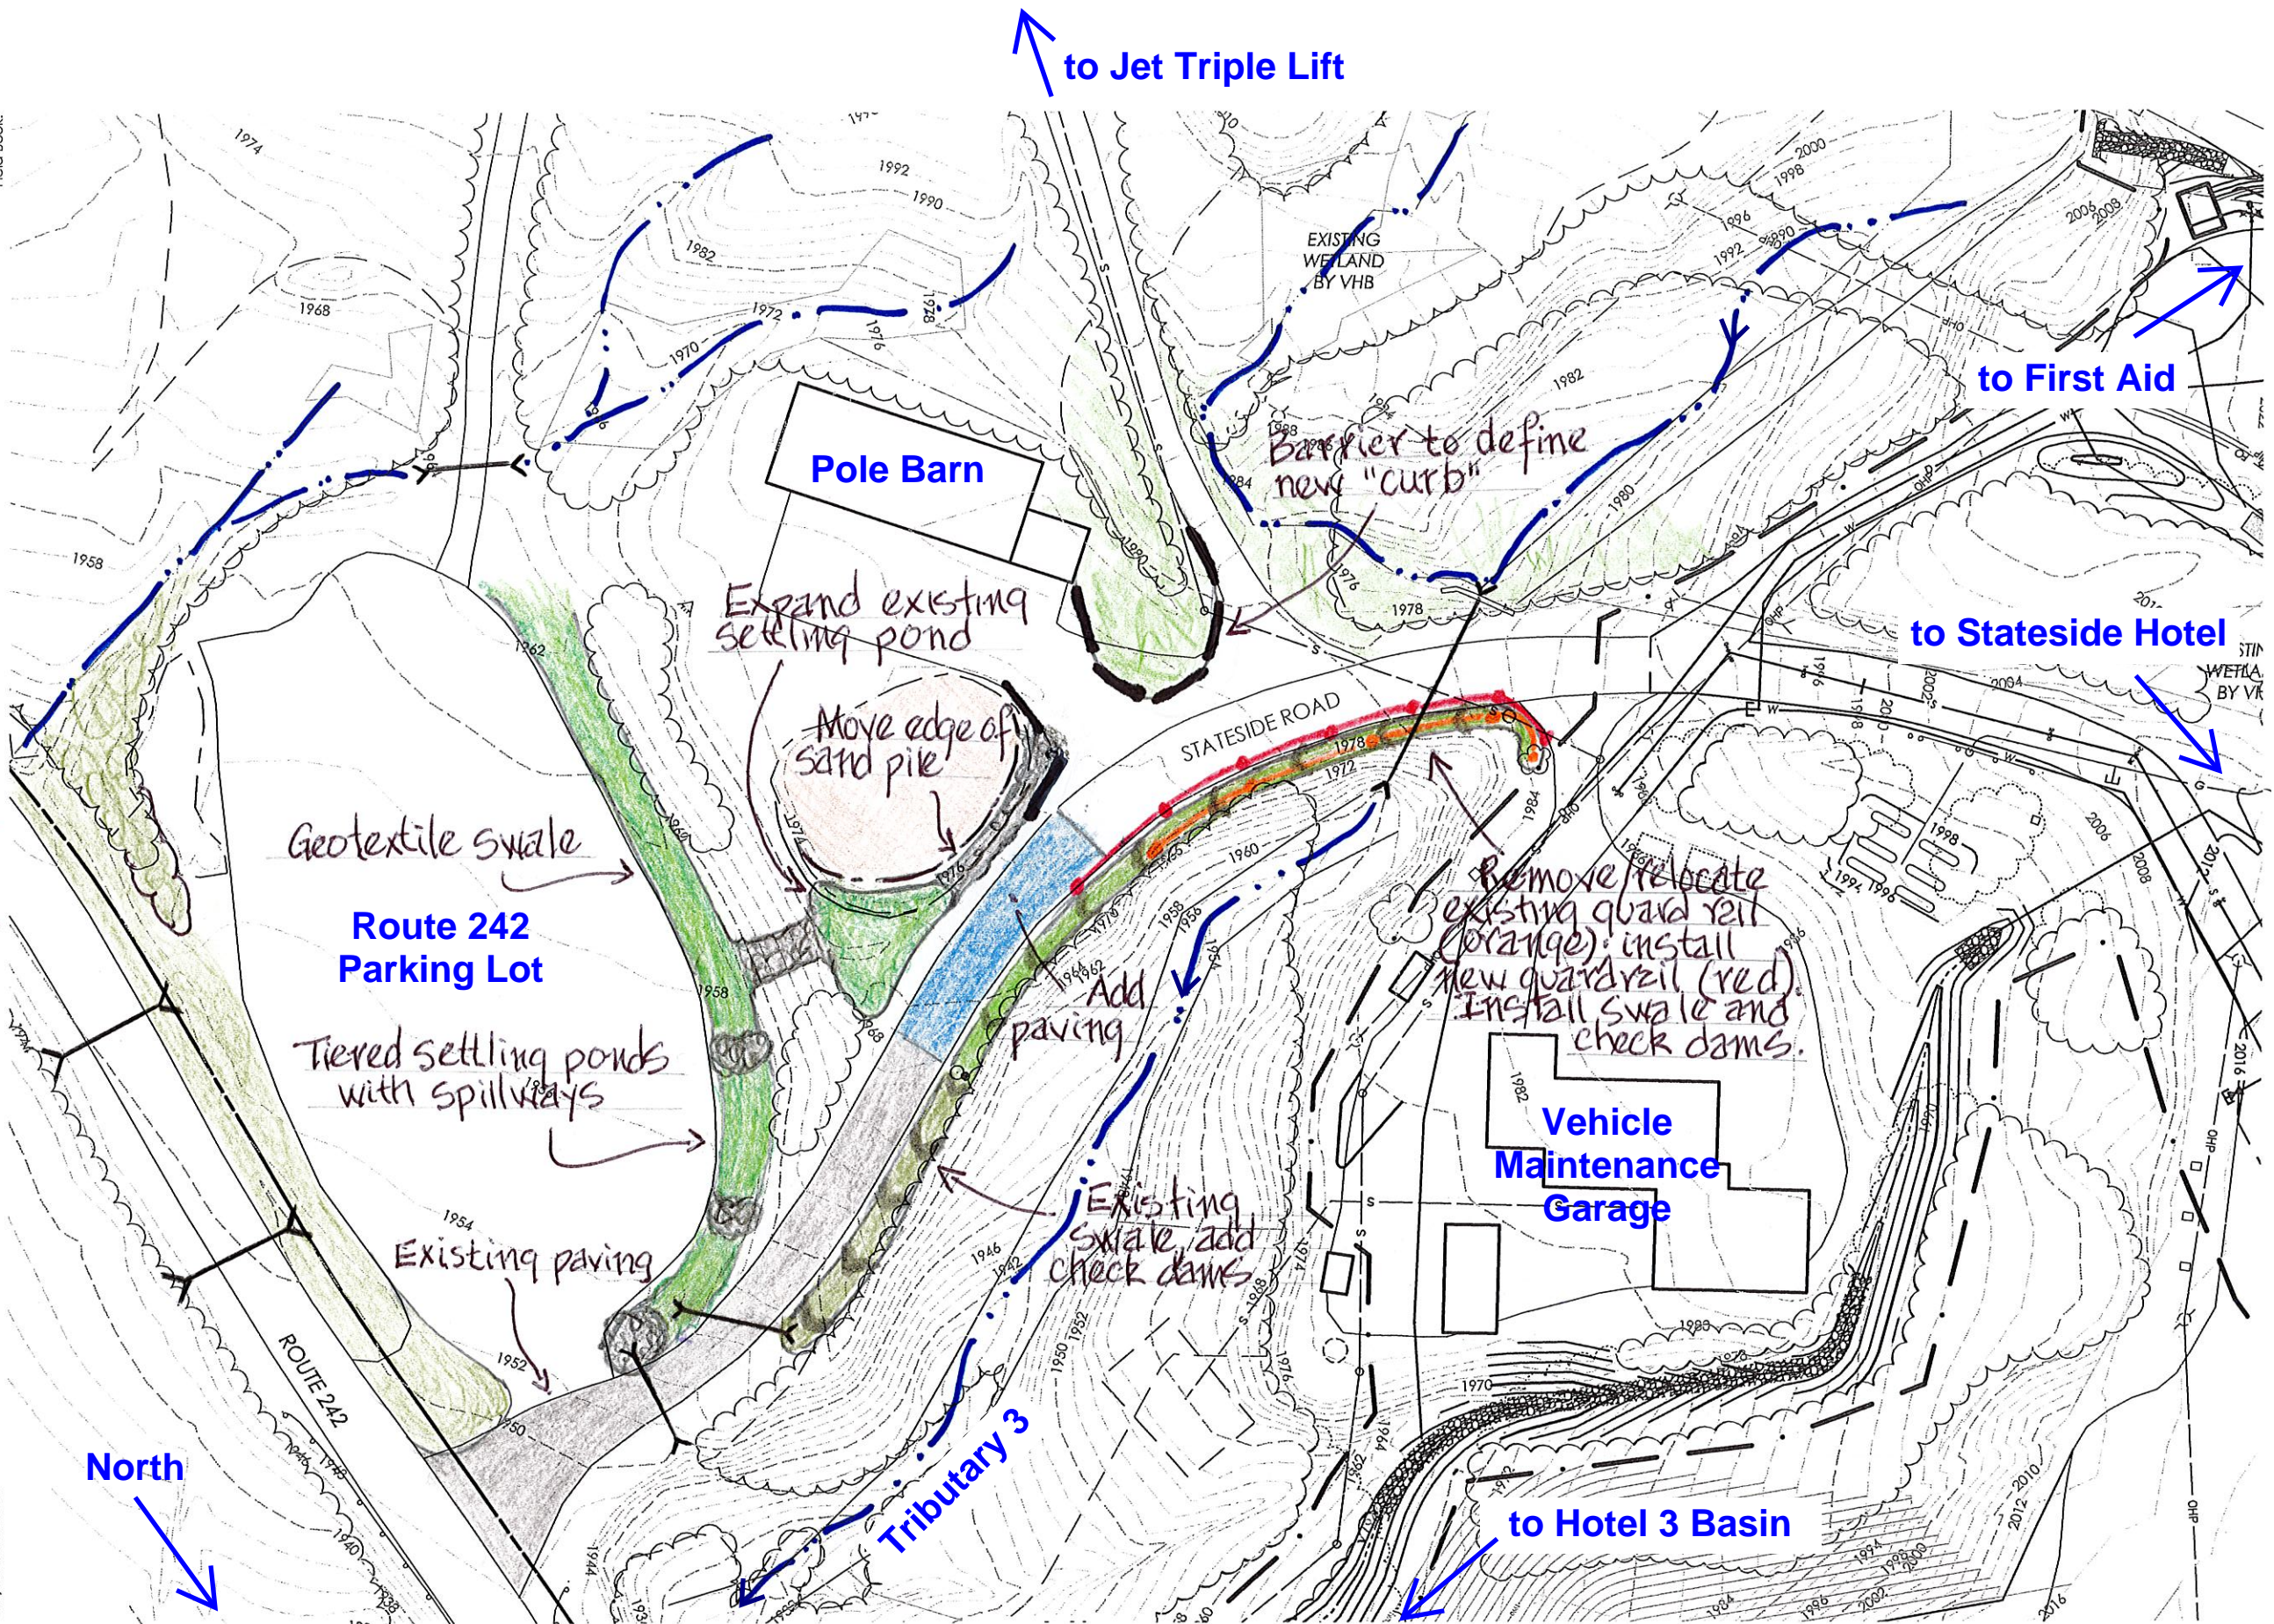
Route 242 Parking Lot Swale

Although the Route 242 gravel parking lot has been the subject of previous improvement efforts under the SST component of the WQRP (#3011), additional opportunities have been found to be present for managing sediment from this area. The swale along the north and west sides of the parking lot has been maintained in the past by reshaping after winter operations are complete and by removing accumulated sediment as needed. It is proposed to be enhanced by the addition of a turf-reinforcing mat ("TRM") geotextile that can be vegetated and will minimize channel erosion. Check dams will also be added to provide additional settling and sediment retention capabilities for snow melt and stormwater runoff prior to discharge to Tributary 3.

Stateside Road Paving

Although the lower portion of Stateside Road between Route 242 and the Pole Barn / Sand Pile Area was paved in 2015, the segment of Stateside Road between the sand pile and the Stateside Lodge has remained unpaved. It is not practicable to pave the entire road surface through this area because snow grooming equipment must traverse the road while crossing between the ski trails south of Stateside Road and the Maintenance Garage north of Stateside Road. Groomers used at the Resort are tracked vehicles with ice spikes and metal grouser bars that would quickly damage and destroy the roadway surface while traversing the paved road. For this reason, the proposed BMPs include paving the remaining segment of Stateside Road east of the sand pile that does not need to be traversed by grooming equipment.

Pole Barn / Sand Pile Settling Pond

A previously-constructed SST (#3013) involved the installation of a rock-lined swale and creation of a settling pond adjacent to the Pole Barn / Sand Pile Area. This settling pond will be enlarged to provide additional settling and sediment retention. The waste block retaining wall around the sand pile will be shifted south to provide additional room for the settling pond and rip rap swale to be expanded.

Stateside Road Swale

A portion of Stateside Road between the lower paved segment and the Pole Barn / Sand Pile Area driveway has a vegetated shoulder but does not include a ditch or drainage swale. Stormwater runoff from this driveway area and Stateside Road may flow over the bank of Tributary 3 without treatment. As an enhancement to a previously-identified SST in this area (#3014), approximately 150 feet of guardrail at the top of the bank will be removed and shifted to the south, allowing for the construction of a rock-lined swale that will connect to the existing swale that starts farther east

along the same side of Stateside Road. Additional settling and sediment retention will be improved by installing rock check dams in both sections of swale. Shifting the guard rail will reduce the amount of untreated impervious area by approximately 900 square feet.

Pole Barn / Sand Pile Area Driveway and Jet Triple Lift Access Road Intersection Improvements

The intersection of the Pole Barn / Sand Pile Area Driveway and the Jet Triple Lift Access Road with Stateside Road has been identified as being an area of existing impervious cover that could be reduced while still allowing adequate room for vehicle turning and tracking of the grooming equipment. In addition to the narrowing that will occur as a result of the guardrail relocation described above, concrete barriers will be installed south of Stateside Road to help define the intersection and reduce the amount of impervious area by approximately 500 square feet.
