MUSSEY BROOK TEMPERATURE TMDL

Draft for Public
Comment – August
2017

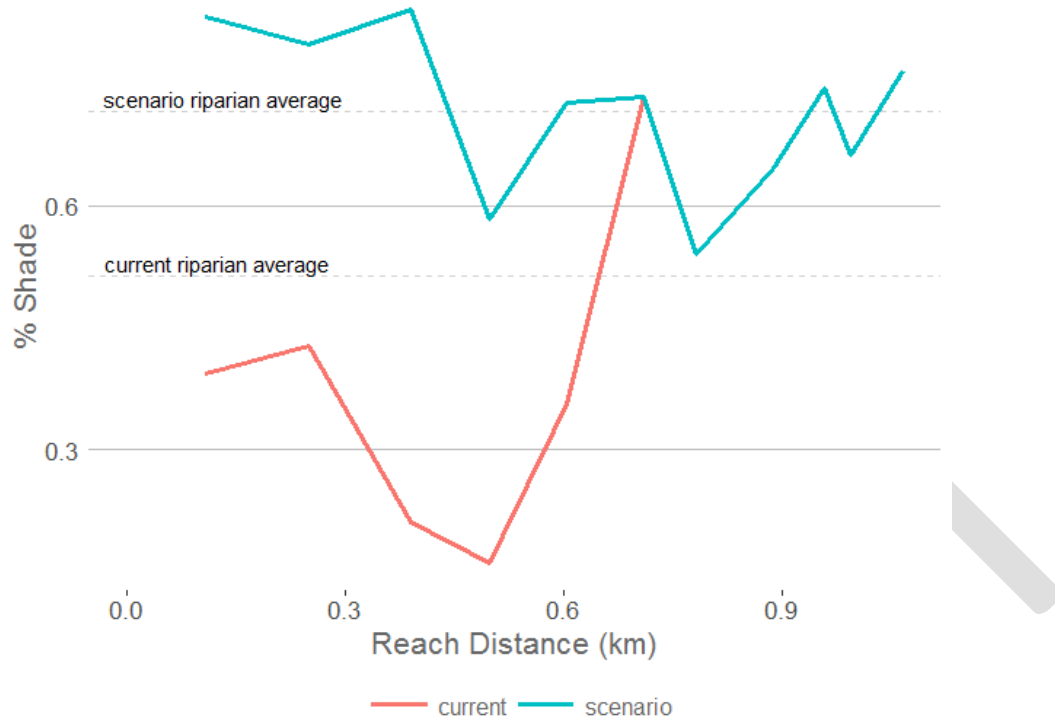
Figure 15 Comparison of average percent shade by reach for current conditions and TMDL scenario. Dotted lines represent average percent shade over the modeled reach.
