River Corridor Protection and Management

FACTSHEET ①

Vermont DEC River Management Program

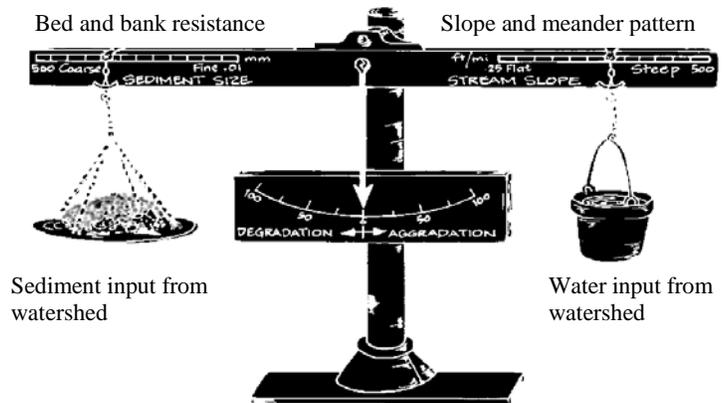
Figure 2. Stable Channel Equilibrium (Lane, 1955)

Figure 1 illustrates a stable channel balance and indicates the relationship between the watershed inputs of water and sediment, channel slope, channel boundary resistance (sediment size), and the physical response of the channel either by aggradation (building up of sediment) or degradation (scouring down). A change in any one of these parameters will cause adjustments of the other variables or a physical response of the stream channel until the system regains its balance.

Stream or river channels are a reflection of what goes into them (water, ice, sediment and woody debris) and the valley type within which the stream is located. The shape of a river channel including its dimension (the width & depth), its pattern (or plan form), and its profile (or slope), is developed and maintained over time by the action of water, sediment and debris that drains from the surrounding area. This “channel forming flow” is approximated by the average annual high water event, which, by virtue of its frequency, does the greatest amount of “work” on the channel and floodplain and transports the greatest volume of sediment over time.

Stable rivers are recognizable by their ability to carry water, sediment and debris, even during high water, without changes occurring in the depth, width, length, or slope of the channel.

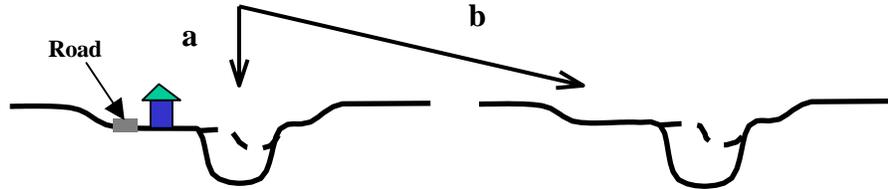
1960a The road is upgraded and relocated into the river corridor encroaching within the historic floodplain.

1960b Channel is widening and migrating laterally in response to the post-1927 flood recovery works (channelization) through bank erosion caused by the increased stream power.

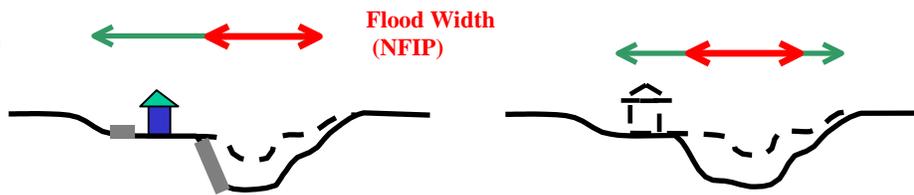
1980a As erosion and lateral migration of the channel threaten residential development and highway infrastructure, the channel bank is armored to prevent or repair damage to human investments.

1980b Channel continues eroding and migrating laterally. NFIP floodway limits are delineated without consideration of the channel undergoing an active adjustment process.

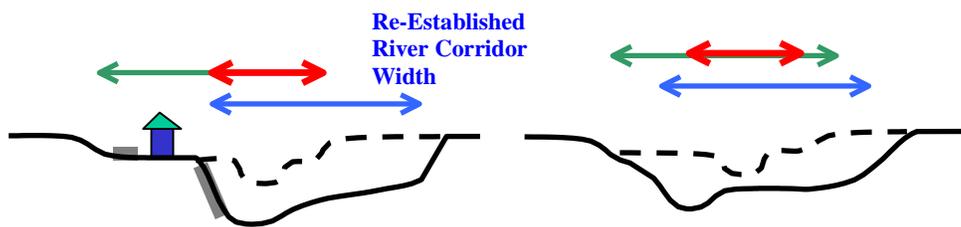
2020a Channel adjustment process is complete.

2020b Channel adjustment process is complete. Channel dimensions and relationship with floodplain are as they existed prior to channelization but at a lower elevation.
